IPR Industrial Services: Chemical Plant Relines Process Sewer Line

Case Study

Pipe Collapse Causes Sinkhole at Chemical Plant. Further Inspection Reveals Leaking Manholes in Section of Process Sewer Line.

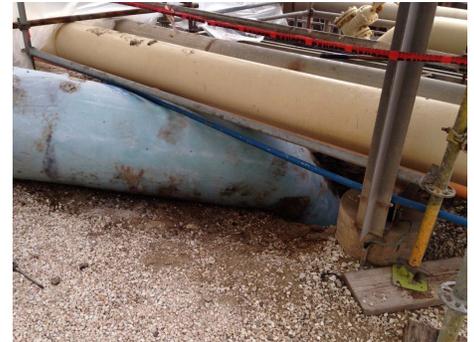
Access point for CIPP liner underneath pipe rack.

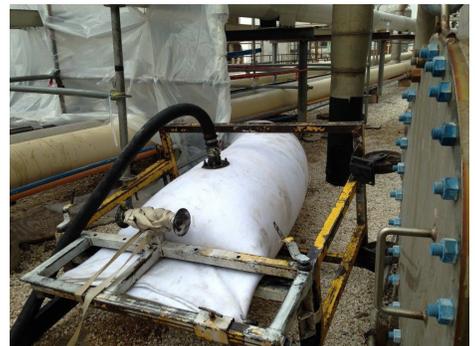
CIPP liner above ground at inversion point.

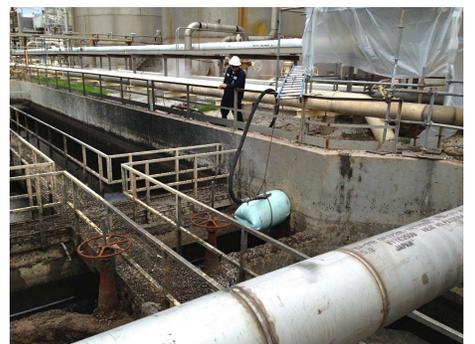
CIPP liner termination point.
