IPR Industrial Services: Pulp & Paper Plant Cooling Line Renewal

Case Study

The Problem: Leaking Raw Water Cooling Line

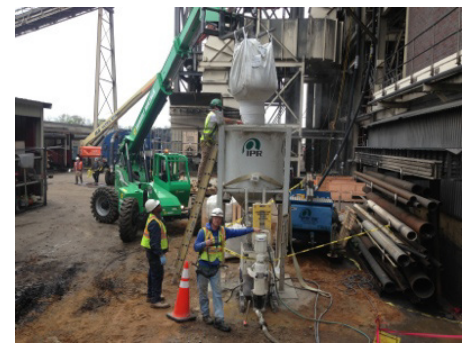
At a pulp & paper mill, a 320 linear foot, 54" diameter raw water cooling line was leaking into a 13,500 kV power supply room. The deteriorated line needed to be repaired quickly to avert a potentially dangerous situation, and to avoid a plant-wide shutdown. Plant officials established a 7-day cold outage to complete the rehabilitation of the raw water line pipe. Two IPR Industrial Services' crews worked around the clock and were able to clean, prep, restore the 320 linear foot line in just 3 days.

A 54" cooling line, lying beneath IPR Industrial Services EcoCast crew, was leaking into a 13,500 kV room shown on the right side of this photo.

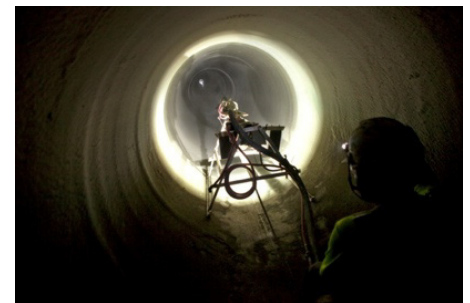
The EcoCast system was lowered into the deteriorated 320 ft. line from a man-way and relined with a structural and corrosion resistant geopolymer.

The EcoCast sled entered and sprayed roughly 1 ft per minute, with the spinning head rotation at 5,000 rpm. The EcoCast geopolymer applied a 1/2 inch max thickness per pass. Three EcoCast coats were applied. After the final pass, the liner became leak-free and structurally restored. CCTV/ Inspection shows no defects and a proper cure. The IPR crews repaired the manhole with a bolt-on blind flange and pressure tested the line before reopening the services.

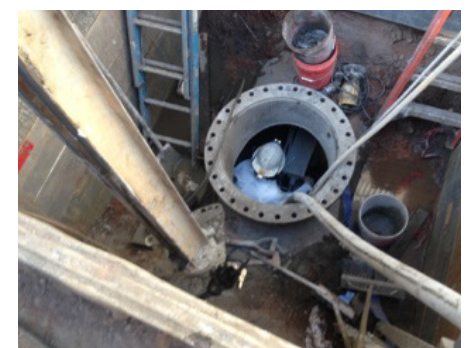
A 30" man-way was cut into the cooling line to gain access.

From start to finish, the IPR Industrial Services' crews quickly and efficiently restored the old raw water line. The ground was excavated to access the top of the pipe. A temporary manhole was cut into the pipe's upstream end and the EcoCast sled gained entry. IPR's industrial safety certified crews cleaned the aged pipe with a high-pressure washer before application.
