# IPR Industrial Services: Chemical Plant Relines Process Sewer Line

### Pipe Collapse Causes Sinkhole at Chemical Plant. Further Inspection Reveals Leaking Manholes in Section of Process Sewer Line.

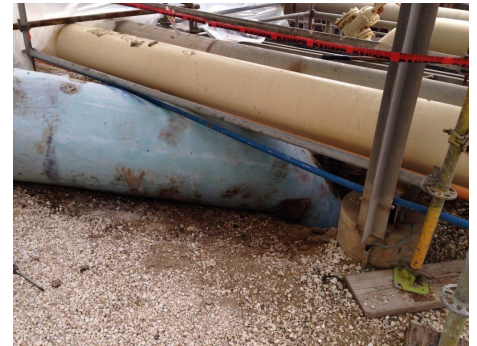
Access point for CIPP liner underneath pipe rack.

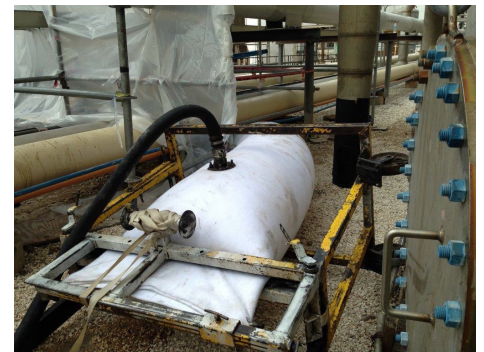
CIPP liner above ground at inversion point.

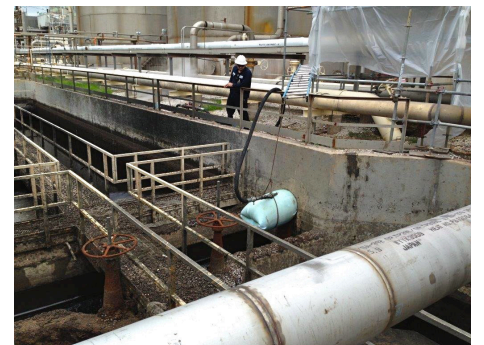
CIPP liner termination point.
