# IPR Industrial Services: Pulp & Paper Plant Cooling Line Renewal

### The Problem: Leaking Raw Water Cooling Line

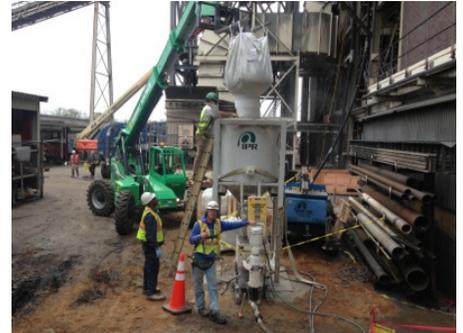
A 54" cooling line, lying beneath IPR Industrial Services EcoCast crew, was leaking into a 13,500 kV room shown on the right side of this photo.

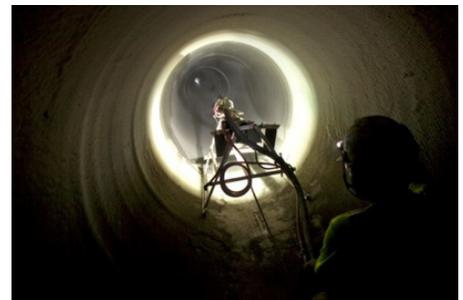
The EcoCast system was lowered into the deteriorated 320 ft. line from a man-way and relined with a structural and corrosion resistant geopolymer.

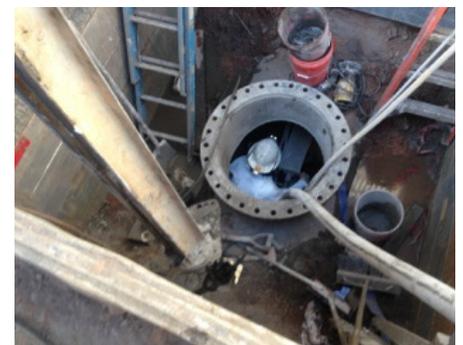
A 30" man-way was cut into the cooling line to gain access.
