EcoCast™ transforms old stone and brick pipe into fully restored combined sewer line.

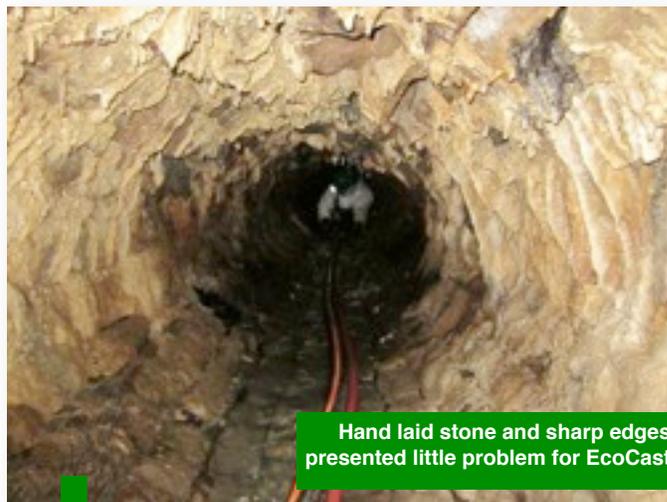
Hand laid stone and sharp edges presented little problem for EcoCast

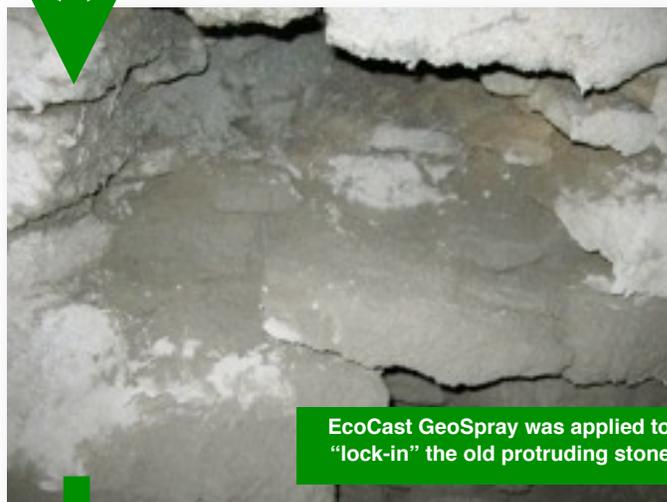
EcoCast GeoSpray was applied to "lock-in" the old protruding stone

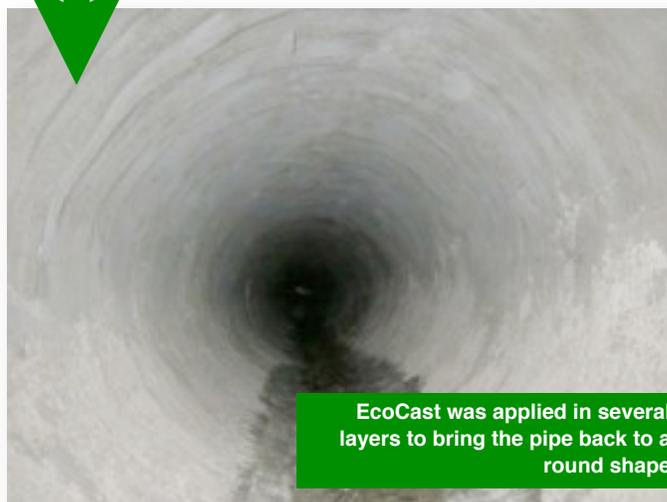
EcoCast was applied in several layers to bring the pipe back to a round shape
