Detroit, Michigan: EcoCast Rehabilitation on 7 ft. 9in.

Owner: Detroit Water and Sewerage Department

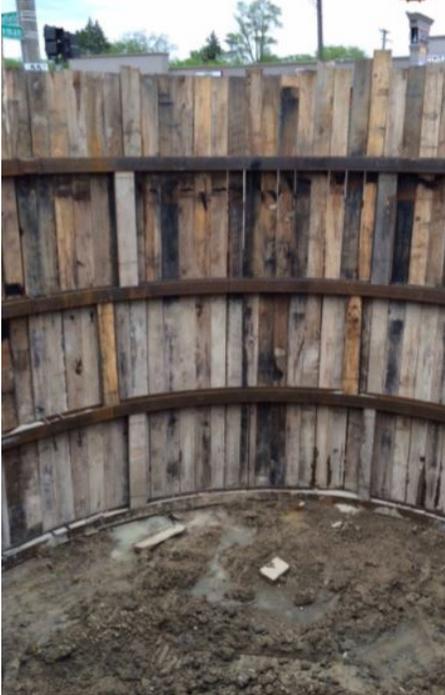
Preparation of 78-inch HOBAS Pipe

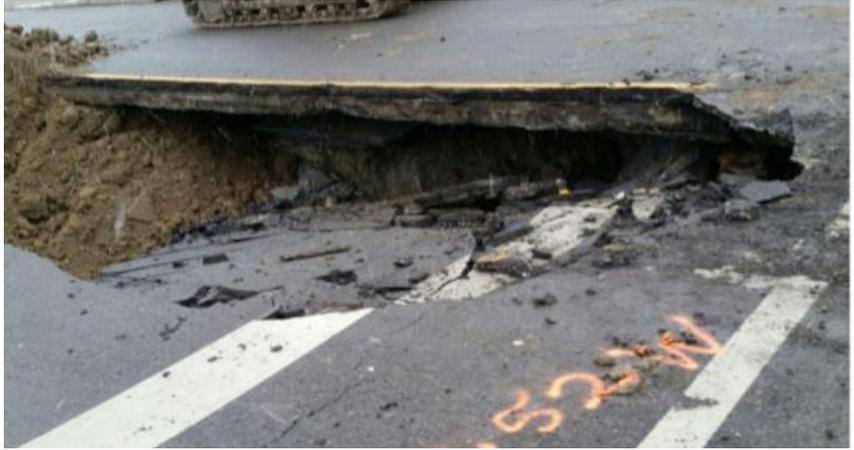
On March 3, 2016, a 12-foot wide sinkhole opened on Detroit's west side on eastbound Tireman Avenue near Greenfield Road. According to the Detroit Water and Sewerage Department (DWSD) the sinkhole was caused by the collapse of a sewer pipe that connects to an interceptor underneath Tireman Avenue. A video inspection showed a connecting pipe had fractured over the interceptor into the Greenfield sewer on the west side of the intersection of Greenfield and Tireman. The surrounding soil (wet sand) entered the 7-foot-9-inch interceptor, thus creating the sinkhole. During the project, further inspection showed that a concrete secondary liner of the interceptor was severely corroded. DWSD contracted with its emergency responder: Inland Waters Pollution Control or IWPC. IWPC is a Detroit-based industrial and environmental service firm whose 45 years of experience is built on the core belief that trenchless infrastructure solutions are critical to bringing the nation's aging water and sewer infrastructure back to standard.

Sinkhole Damage on Tireman Avenue

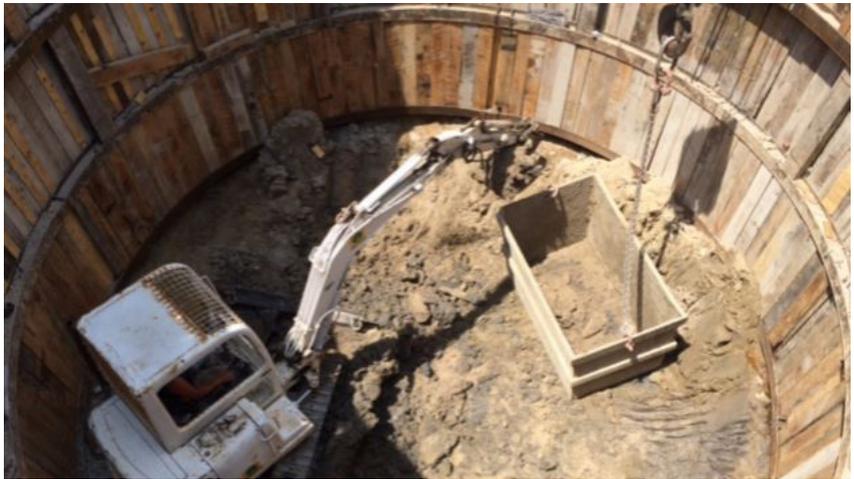
78-inch HOBAS Pipe

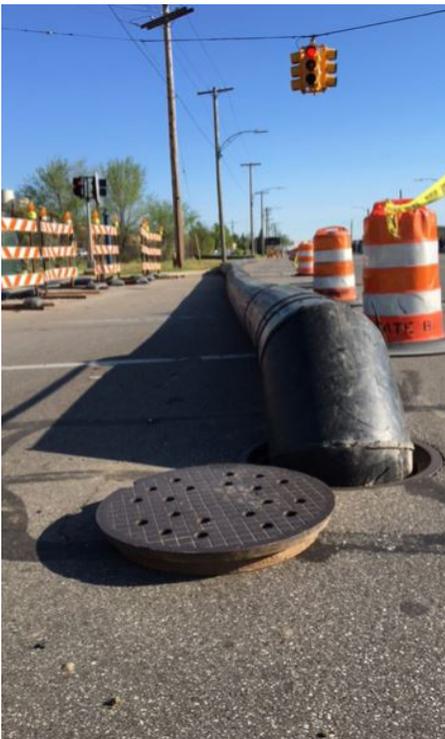
Temporary Bypass Installation

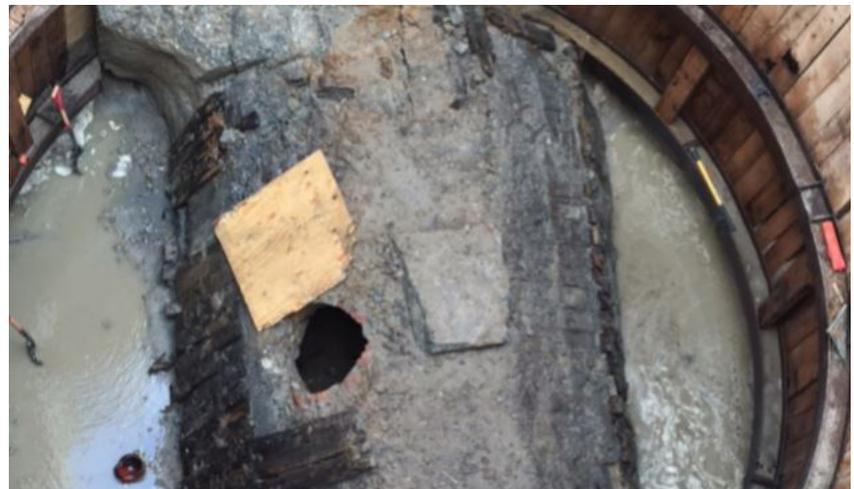
78-inch HOBAS Pipe with preparation of manhole entry point
