City of Houston: 72" CIPP and EcoCast Restoration

Owner: City of Houston

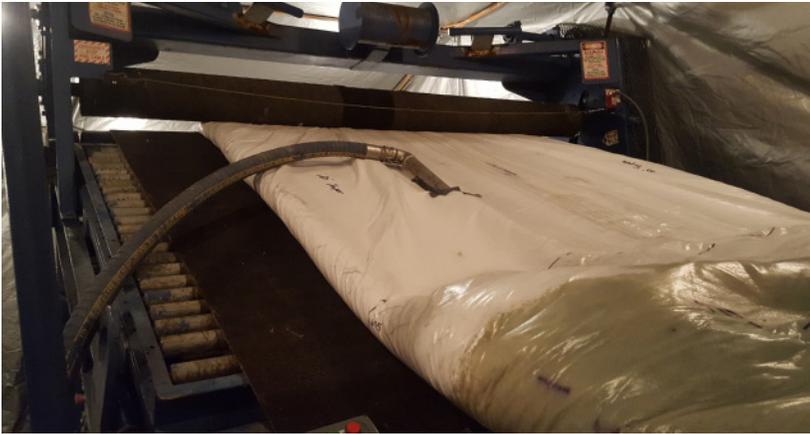
72" CIPP Liner Resin Impregnation Process

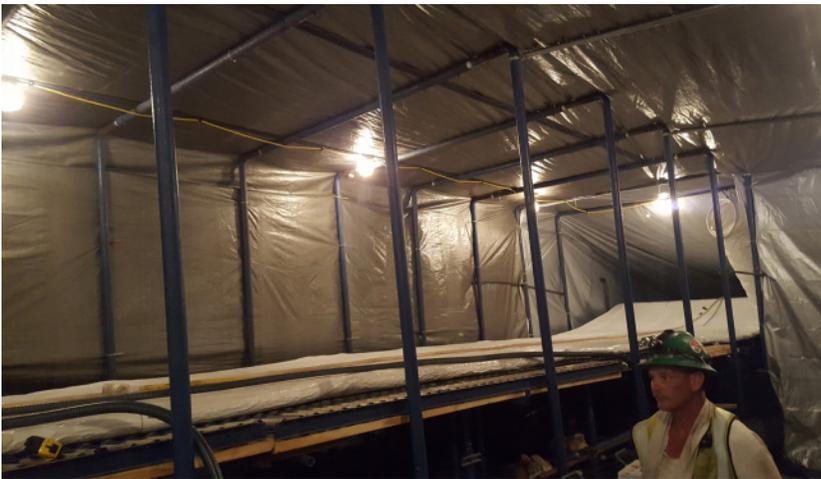
72" CIPP Liner Wet Out Process

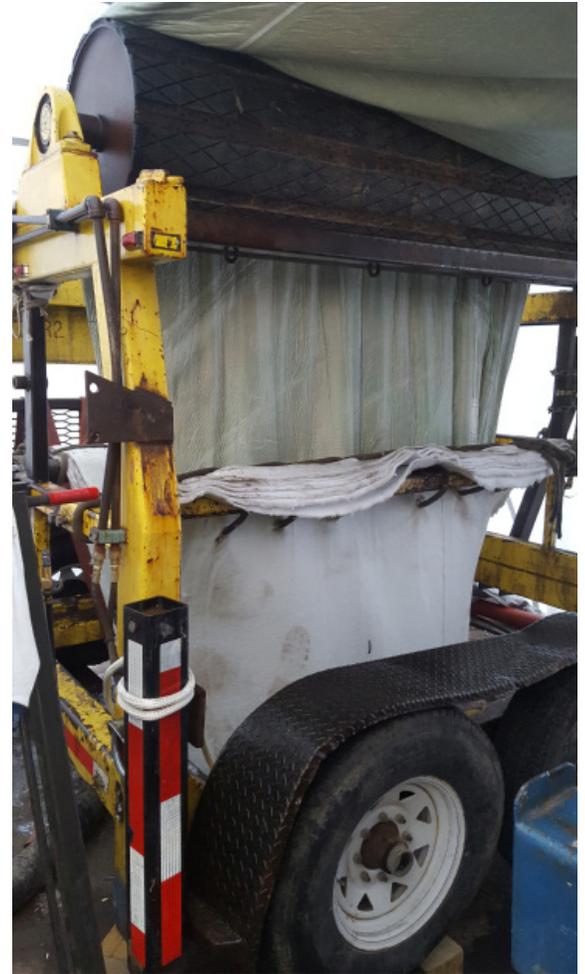
72" CIPP Inversion Process

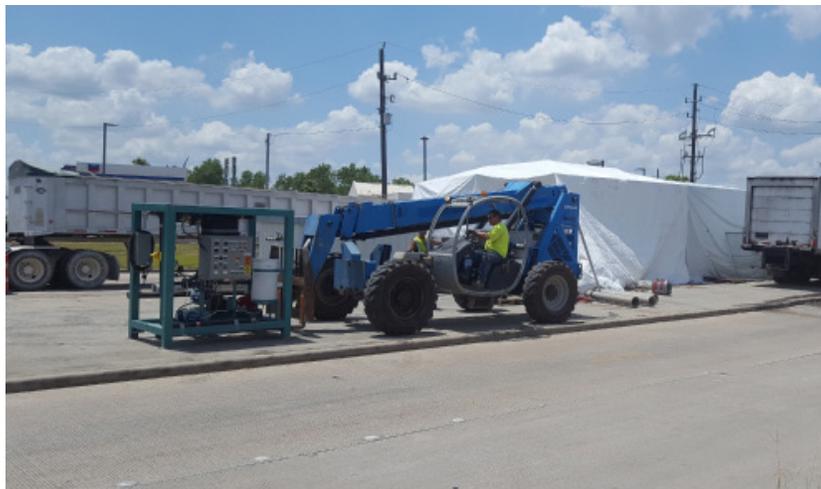
CIPP Installation Site
